CanSat Leader Training  
Program (CLTP) - 8<sup>th</sup> Cycle

# Final Presentation

## **Estimating Impact-Force of a Re-entry Vehicle For Hazardous Analysis and Structure improving**

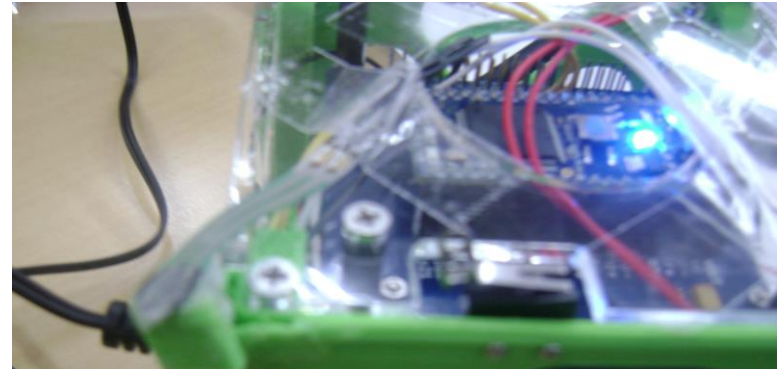
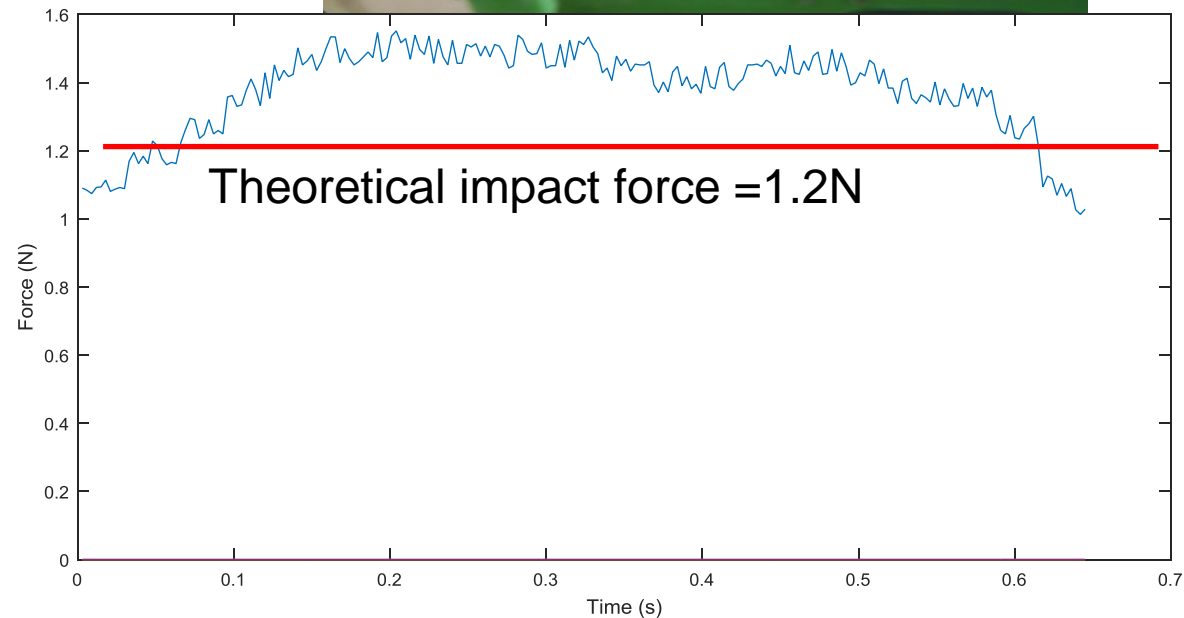
## (1) Payload

The satellite were dropped from a 50 cm height and data were recorded.

The load shows on one leg only and by inspection of satellite this leg was broken due to higher stress.

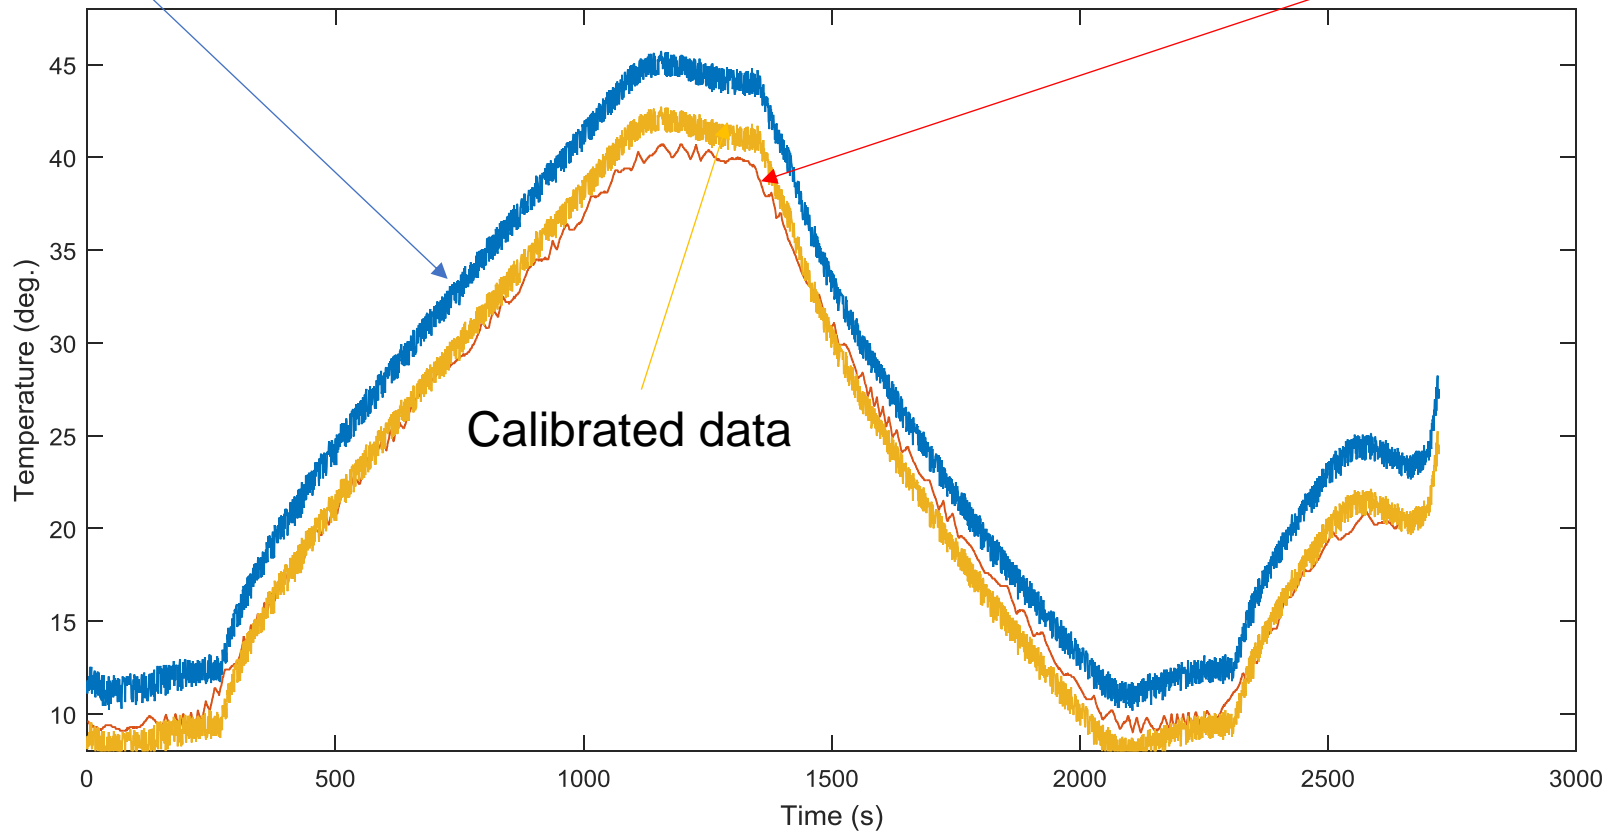
## (2) Thermal sensor calibration

HEPTA sat Thermal sensor

Thermal Chamber

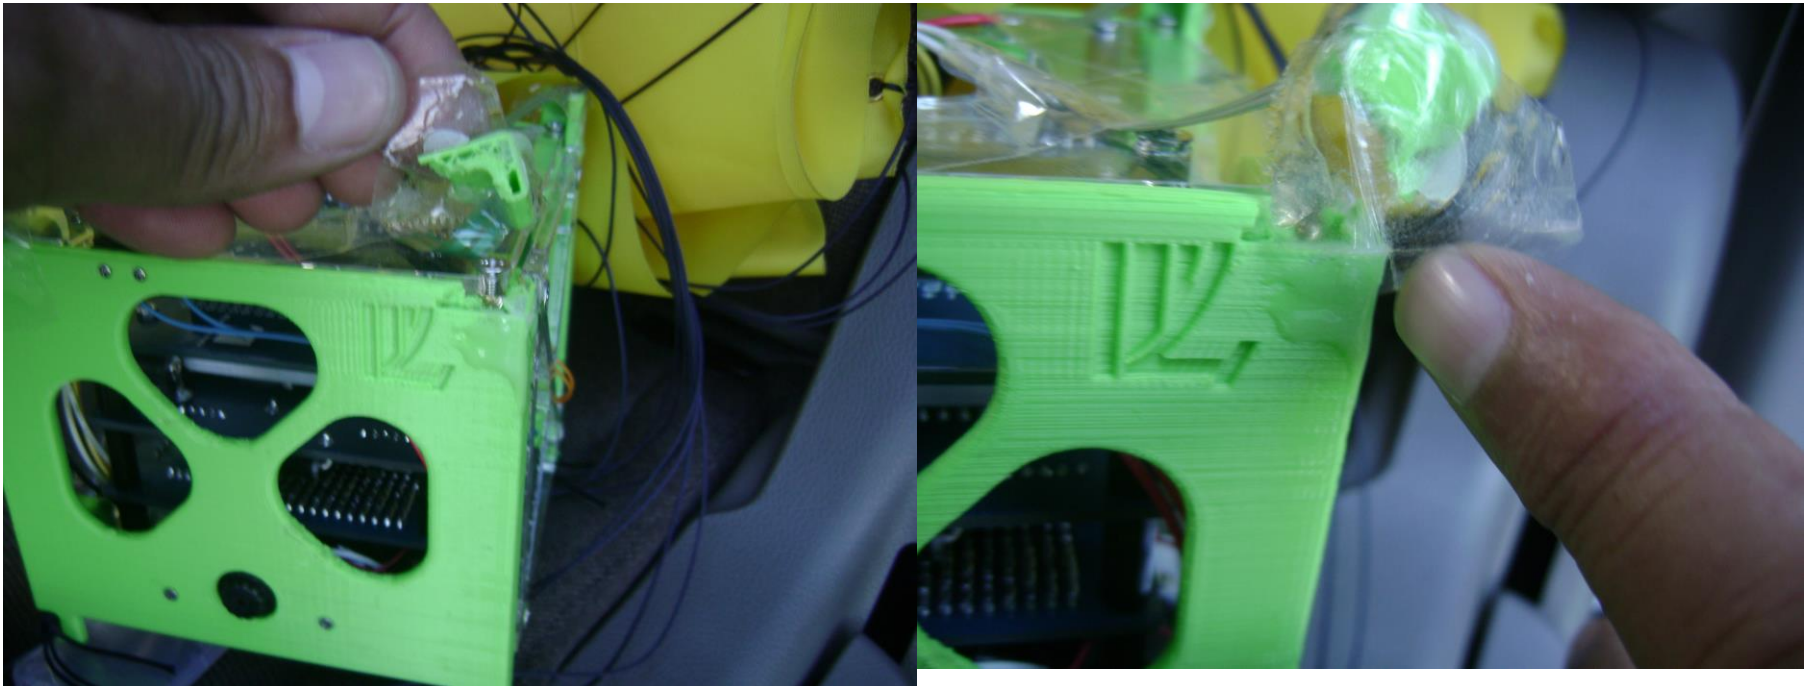
# Controlled drop on Grass

I did several drops on the grass from random altitude and could get one reading each drop ranging from 400gf to 1500gf (4-15N)

- FSR are working fine for calculating impact forces under controlled experiment (drop test).
- In real flight nothing can guaranty that the satellite will land on its
- legs.
- Impact force can break
- the leg of the satellite.
